Brite Lites Product Bulletin

p/n: TLEDPOLA

Date: January 11, 2016

Description: Polaris IQ LED taillight Insert – CFI models

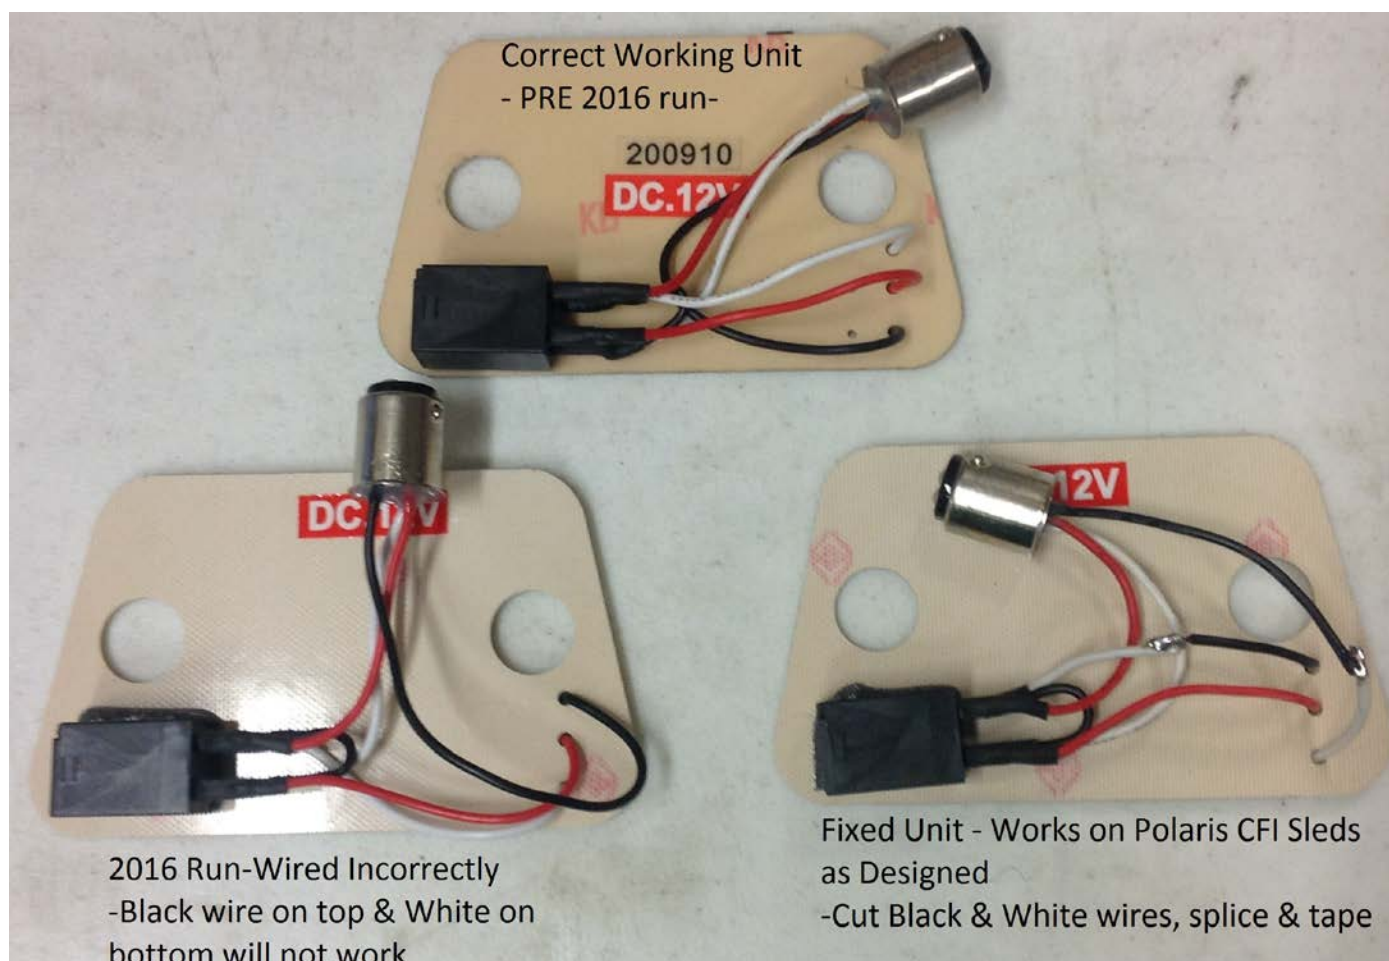
Problem: Current production batch from September 2015 was built with wiring crossed and the unit will not operate on the intended CFI type Polaris snowmobiles. (2007 thru 2014 IQ chassis)

Identification: The parts affected can be visually identified by looking at the back side of the board to see if the Black color wire is located in the upper hole or the lower hole in the PC board. In the picture below, the top unit is wired correctly and from a prior run of units. The lower left corner is a unit produced in September and will not function as wired.

Solution: The fix to make the unit operational as intended is very simple. The lower right unit shows the fix. Just switch the Black and the White wires by either cutting and splicing as shown, or by unsoldering from the board and re-soldering to the board with the Black wire on the lower position, so it looks like the unit in the top picture. Once soldering is completed, exposed wires should be sealed with electric tape or heat shrink tubing.

If you would like to have a purchased unit that is not wired correctly replaced instead of re-wiring locally, you have the option to mail it into us and we will gladly replace it with a unit that has been tested and is working properly.
